Manhole Inspection Summary

Manhole # S09Y__010MH

Insp Date: **4/22/08 8:24 AM**

Location Address: **1229 S Grantley ST**

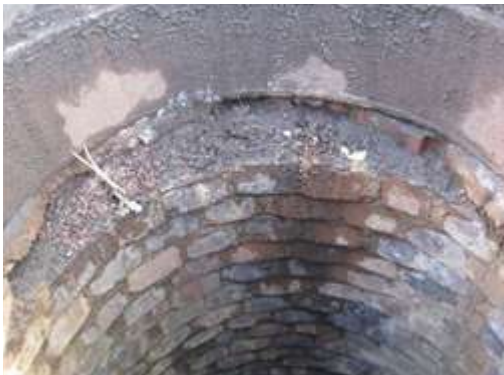
Defect 3

Condition: ☐ Sound ☐ Cracked ☐ Root Intrusion ☒ **Loose Brick** ☒ **Deteriorated**

Infiltration: ☐ None ☒ **Joint** ☐ Cracks ☒ **Mortar** ☐ Roots ☐ Wall

chimney loose bricks and deteriorated, infiltration at joint

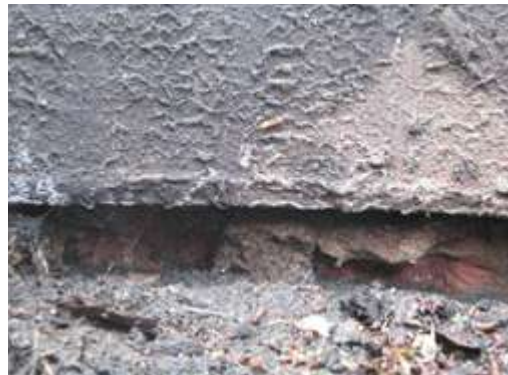
Defect 2

☒ **Leaks**

frame/chimney joint - infiltrations

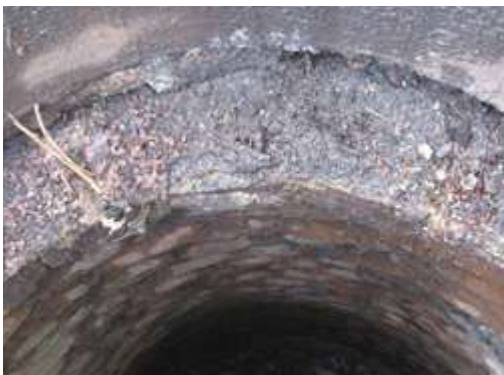
Defect 1

Offset: **4** (in.)

offset

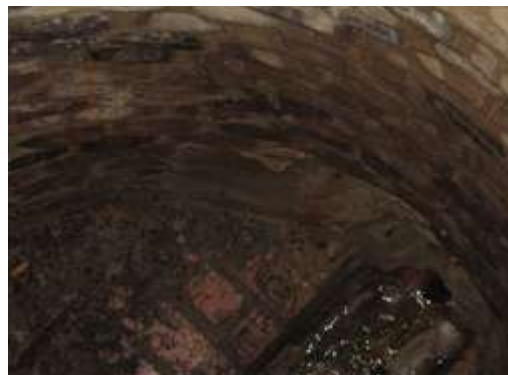
Defect 4

Infiltration: ☐ None ☐ Joint ☐ Cracks ☐ Mortar ☐ Roots ☒ **Wall**

signs of infiltration at barrel

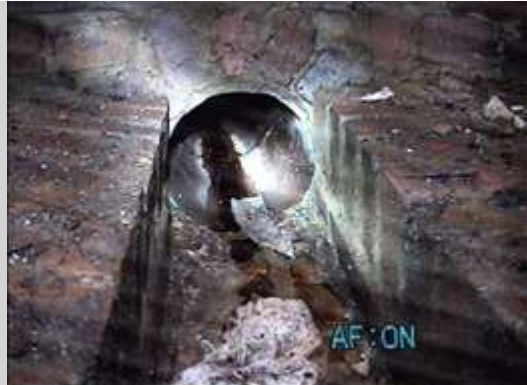
12 O'Clock Outflow

Pipe Height: **12** (in.) Rod and Bar (Angled)
Pipe Material: **Clay** ☐ Pipe Lined
Invert Depth: **8.70** (ft.) Flow Characteristics: **Slow**
Deposits: ☒ None ☐ Mud ☐ Sludge ☐ Debris ☐ Grease
Silt Depth: **0** (in.) Deposits Extent:
Infiltration: **None** Pipe Seal Cond: **Sound**

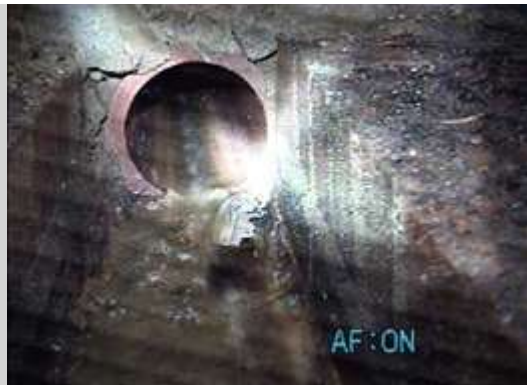
6 O'Clock Inflow

Pipe Height: **6** (in.) Rod and Bar (Angled)
Pipe Material: **Clay** ☐ Pipe Lined
Invert Depth: **8.75** (ft.) Flow Characteristics: **None**
Deposits: ☒ None ☐ Mud ☐ Sludge ☐ Debris ☐ Grease
Silt Depth: **0** (in.) Deposits Extent:
Infiltration: **None** Pipe Seal Cond: **Sound**
